TECHNICAL REPORT ARCCB-TR-97021

HYDROGEN CRACKING DURING SERVICE OF HIGH STRENGTH STEEL CANNON COMPONENTS

SEPTEMBER 1997

**US ARMY ARMAMENT RESEARCH,
DEVELOPMENT AND ENGINEERING CENTER
CLOSE COMBAT ARMAMENTS CENTER
BENÉT LABORATORIES
WATERVLIET, N.Y. 12189-4050**

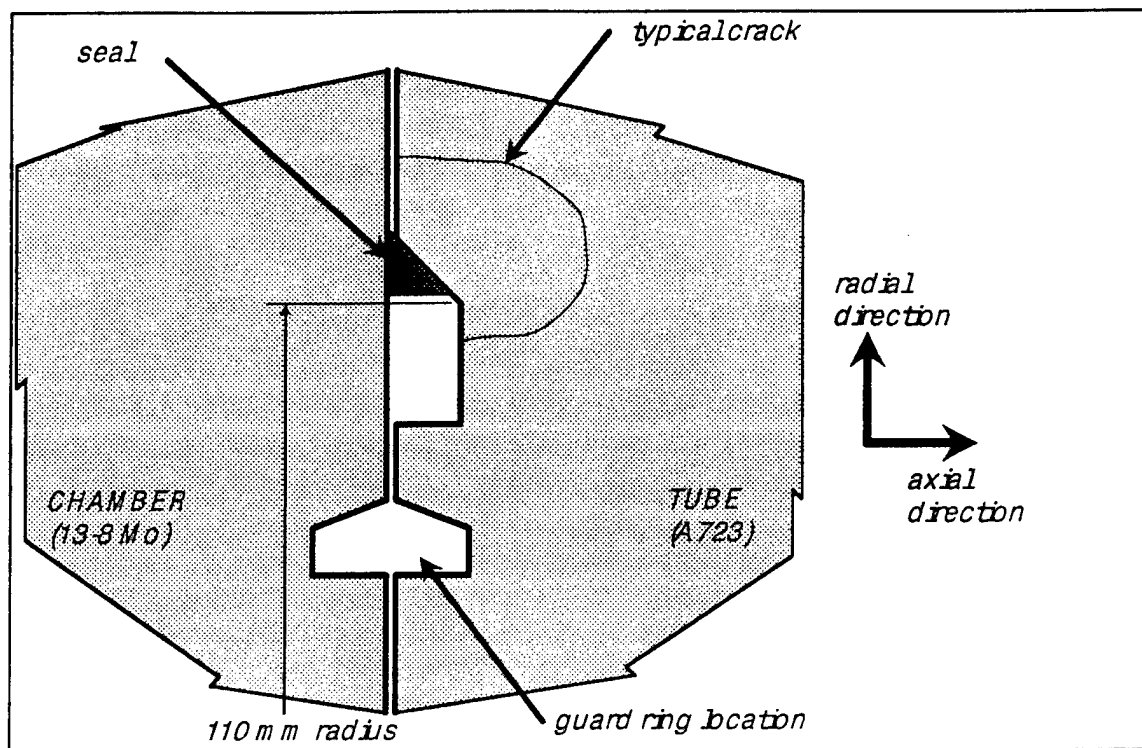
Cracking in the prototype cannon with the seal at location #1 was suspected due to a small pressure leak that was observed during the fifth firing cycle. The typical crack size and location sketched in Figure 2 show a 21-mm (surface length) crack that provided a pressure path around the seal and thus accounted for the observed leak. Two other cracks were observed at other angular positions of the seal, a 19-mm surface length crack at a position 185° away from the 21-mm crack, and a 6-mm surface length crack 111° away from the 21-mm crack. The angular positions are significant because the two largest cracks were within a few degrees of alignment with the two 180°-spaced vent holes in the guard ring, and the 6-mm crack was closely aligned with a plugged test hole in the guard ring contact surface of the tube. The presence of the plugged hole could have affected the contact surface and allowed passage of combustion products at this location. Thus, each of the three positions of cracking was closely aligned with angular positions of known (guard ring vent holes) or suspected (plugged hole) sources of propellant combustion products. This is strong evidence that the source of the environment that contributed to the cracking was the combustion products. Regarding initiation of the three cracks, each of the three cracks included the internal corner of the seal pocket adjacent to the seal. This corner is a likely origin of cracking. As shown in Figure 2, the larger two cracks extended farther from the corner toward the outer radius of the tube rather than toward the inner radius; this can be

explained in terms of the residual stresses in the cannon tube, discussed in the next section. The 6-mm crack was nearly centered on the internal seal pocket corner, thus indicating that this seal pocket corner was the origin of the cracks.

At this point in the work, the following interim conclusion was drawn: the cracking in the prototype cannon with the location #1 seal, given an aggressive environment and susceptible material, was caused by the tensile hoop direction overstrain residual stress and the stress concentration at the internal seal pocket corner adjacent to the seal. Based on this conclusion, the location #1 configuration and any further analysis of this location were abandoned. These decisions were based on:

FIG. 2 - Sketch of Seal Location #1 and Cracking Observed

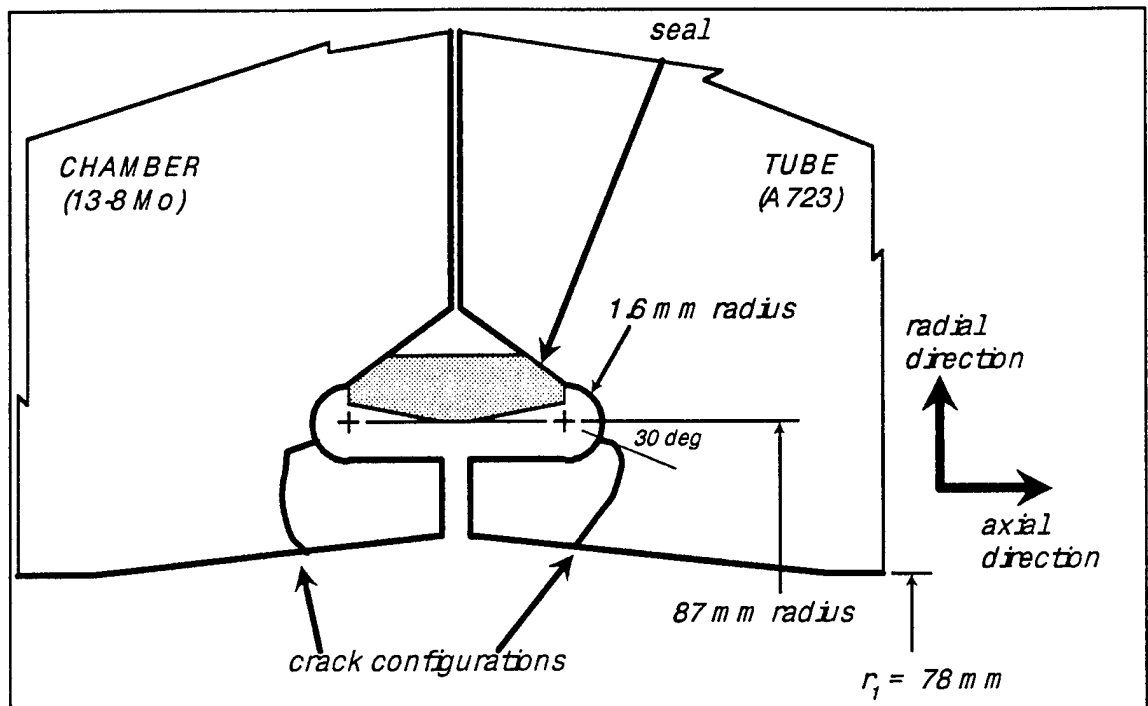
Cracking in the prototype cannon with the seal at location #2 was found to be quite extensive when the cannon was disassembled after thirty firing cycles. Nearly identical crack configurations were observed in both the chamber and tube sections of the cannon, initiating from a location in the seal pocket about 30° from the axial direction in each section; see Figure 3. The cracks extended through to the inner radius surface and extended about 50 mm in the circumferential direction in each section. The similar location, size, and orientation of rapid cracking in components of different material is quite remarkable. The similar cracking suggests that a significant load was applied about equally at locations close to the seal pocket radius of both the chamber and tube, thereby overwhelming the expected differences in cracking resistance of the two materials. Referring again to Figure 3, the seal contact load that is applied to the seal surfaces of the chamber and tube meets this criterion of a significant local load being applied to both cannon sections. The question of whether or not seal contact loads can result in tension stresses in the seal pocket radius will be addressed later, in relation to the finite element results.

Attempts were made to view the location #2 fracture surfaces near the initiation of cracking at the seal pocket radius. However, these fracture surfaces had long since been removed by thermal and chemical action of the combustion products impinging on the crack surfaces during firing. Apparently, after cracks had grown through to the inner radius of the chamber and tube, the direct blast of combustion products quickly obliterated the fracture surfaces.

The cause of cracking at location #2 of both the A723 tube and the 13-8 Mo chamber sections of a prototype cannon, given the presence of hydrogen-laden propellant products and susceptible high strength steels, was the sustained tensile stresses arising from assembly preloads required to maintain pressure seals between cannon components. The seal contact load produced a sustained tensile stress in the seal pocket radius near the location of the observed cracking. The end load between the tube and chamber produced a small addition to the sustained tensile stress at the observed cracking location. Firing pressure loads may have contributed to the initiation of cracking and are believed to be the predominate cause of continued growth of the cracks.

FIG. 3 - Sketch of Seal Location #2 and Cracking Observed

A reduced level of sustained tensile stress near pressure seals in these cannon components can be accomplished by design changes that reduce stress concentrations near the seal contact area. An increased seal pocket radius and a machining process with smaller inherent defect size would reduce the sustained stresses. A small further reduction in sustained stress can be accomplished by increasing the separation distance between the seal pocket area and areas of end load between cannon components.

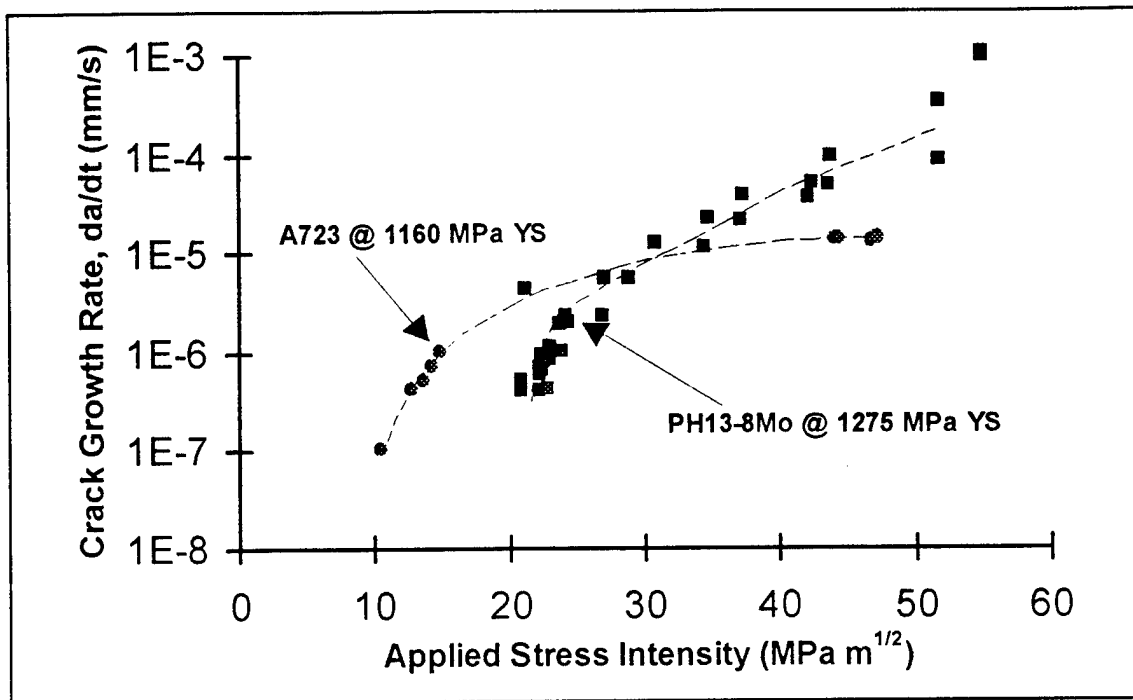
Laboratory hydrogen cracking tests (ref 3) have been performed in response to the earlier environmental cracking incident (ref 1) and to the cracking under discussion here. Results from the prior work with direct application to the discussions here are shown in Figure 5. Bolt-loaded compact specimens were machined from the tube and chamber sections described here and tested in an electrolytic cell containing a 3.5 percent aqueous NaCl solution containing As_2O_3 poison and using a current density of 40 ma/cm^2 . Additional information on the tests is in Reference 3. Crack growth rate from a five-point moving average varies over four orders of magnitude for the two materials. A larger increase in da/dt with increasing applied K was noted for the 13-8 Mo steel, compared with A723. The two materials had about the same da/dt of 10^{-5} mm/s at an applied K of $30 \text{ MPa m}^{1/2}$. Since there was a similar amount of observed cracking at location #2 for the chamber and tube cannon sections, it will be interesting to see if this value of $30 \text{ MPa m}^{1/2}$ is consistent with the calculation of applied K based on finite element results, described later.

The value of applied K determined above, 34.7 MPa m^{1/2}, compared with the growth data in Figure 5, can account for the cracking observed at location #2 in both the A723 steel tube and the 13-8 Mo steel chamber. Of course, the value of applied K depends on the assumption of a 0.1-mm deep, 0.02-mm radius defect, but these values are believed to be representative of typical manufacturing methods. Recent work (ref 8) in fatigue initiation with cannon components supports this belief.

FIG. 5 - Hydrogen Cracking for Two Steels; 3000 hours in Electrolytic Cell

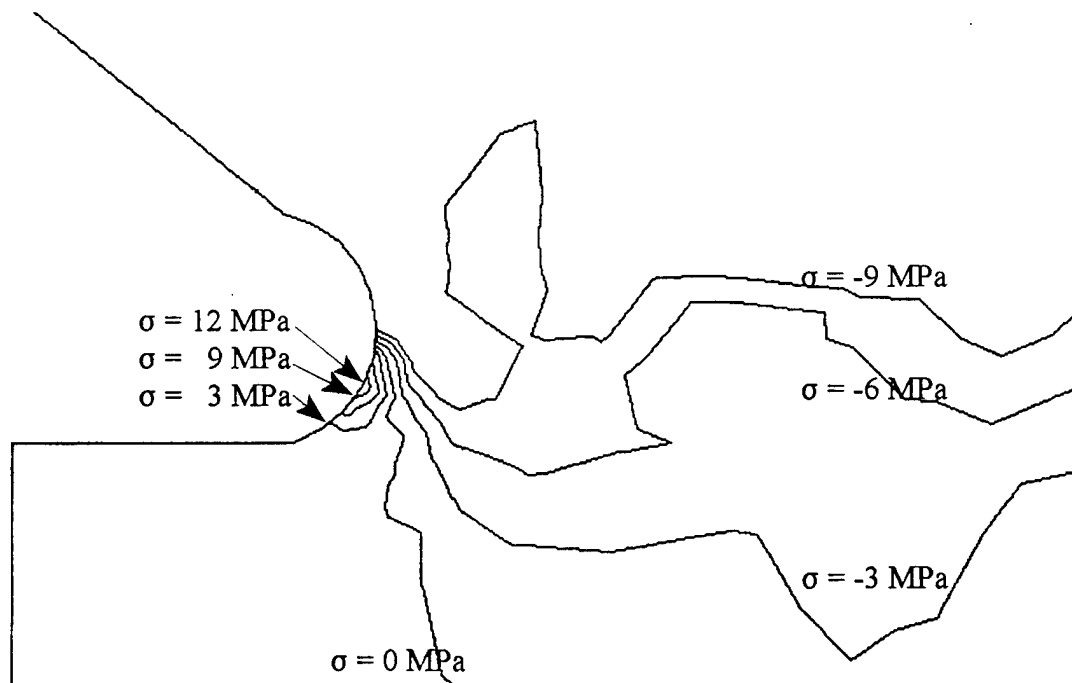
Results of the finite element analysis are given in Figures 8 and 9, which show contour plots of the radial direction stresses in the area of the seal pocket. Recall from Figure 3 that the location #2 cracking in both components started within 30° of normal to the radial direction. Figure 8 shows the radial stress distribution resulting from the 156 MPa end load. The maximum radial tensile stress in the seal pocket radius is 12 MPa at an angle of 29° from the radial direction, compared with 30° from the radial direction for the observed cracks in Figure 3. Note that most stresses in the area of the seal pocket are compressive and that the $\sigma = 0$ contour approximates the direction of the observed cracks shown in Figure 3. Figure 9 shows the radial stress distribution resulting from the 3023 MPa seal contact load. The maximum radial tensile stress in the seal pocket radius is 233 MPa at an angle of 14° from the radial direction. As with Figure 8, most stresses in the area of the seal pocket are compressive and the $\sigma = 0$ contour approximates the direction of the observed cracks. It is clear from these results that stresses from both end loads and from seal contact loads can account for the initiation location and the growth directions of the observed cracking, and that the seal contact loads have the more significant quantitative effect on cracking. Next, these results will be used to calculate the approximate value of applied stress intensity factor, for comparison with the measured crack growth rate versus applied K data presented earlier.

FIG. 8 - Radial Stresses for Location #2 with Average End Load of 156 MPa

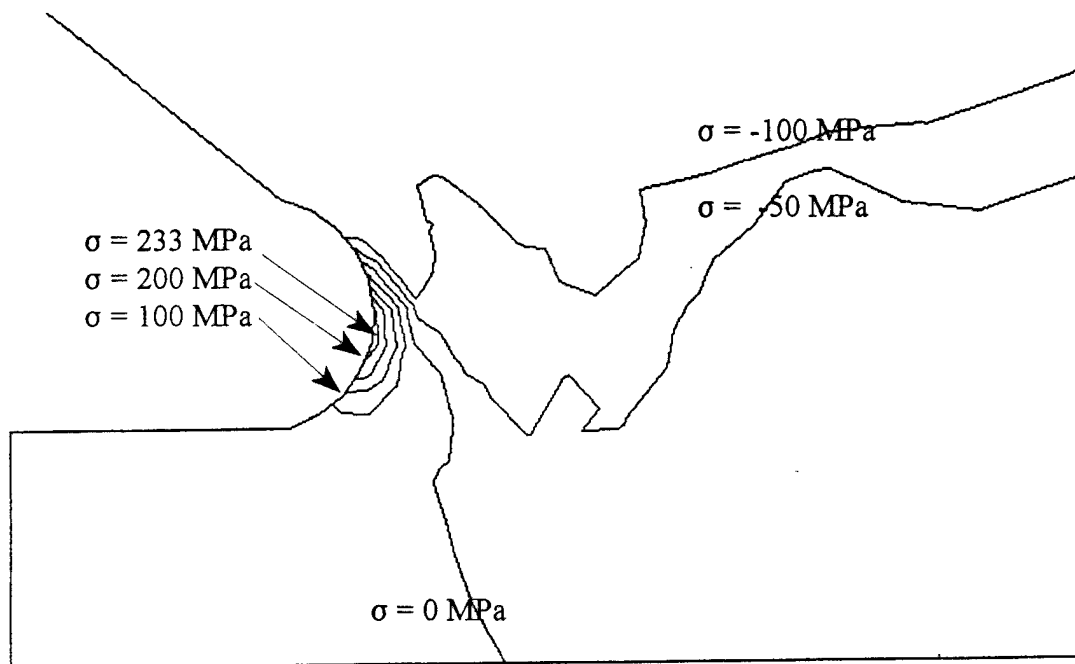
FIG. 9 - Radial Stresses for Location #2 with Average Seal Load of 3023 MPa
